A PRELIMINARY INVESTIGATION

REGARDING THE DESIGNATION OF A PROPOSED AREA IN NEED OF REDEVELOPMENT

AREA C

(ROUTE 23 NORTH – MABIE TO HIGH STREETS)

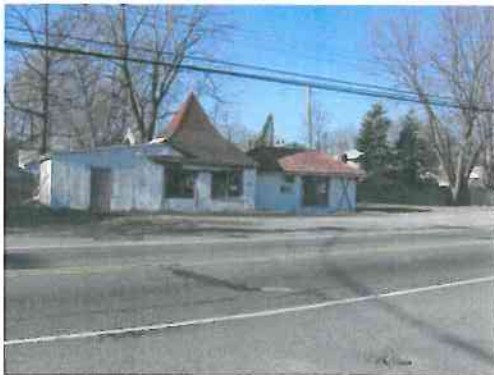
BUILDING # 1

Both buildings are in a very poor, dilapidated condition. Some of the windows are covered by boards. Furthermore, peeling paint, deteriorated roofing, plus other obvious signs of neglect, indicate that each structure has reached the end of its useful life. It does not appear that it would be cost effective to attempt to rehabilitate either structure. In addition, Building # 1 is a very small building, not useful by today's commercial standards and both it and Building # 2 are located in close proximity to Route 23. Finally, accommodating adequate parking on the site is very difficult because of the current placement of the buildings on the property.

In summary, this property meets at least criterion “a” because of the persistent pattern of neglect and may meet other criteria as well.

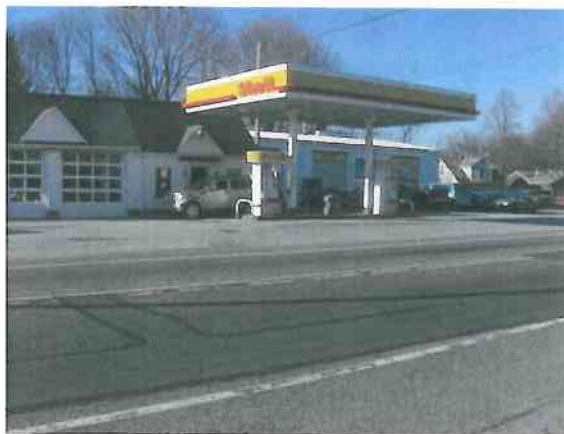
SHELL SERVICE STATION

The service station building consists of an office area and two repair bays, totaling 1,825 sq ft, but it appears that the repair bays are used for storage not for repair purposes. This single story masonry building appears to be in excess of 50 years old, based on the Tax Assessor’s records and visual observation. Immediately to the north of this building and partially attached to it is a single story metal building which accommodates the aforementioned auto repair operation. And consists of 2,400 sq ft of floor area This building accommodates three repair bays. Both buildings are in fair to good condition. However, the placement of the buildings on the site, the somewhat difficult access related to the gas pumps and the manner in which vehicles are parked on the site are indicators that this site falls short of the current standards for commercial uses of this type. It should be noted that although service stations are permitted in the HC Zone, this use as currently configured, would have difficulty obtaining an approval without multiple variances

The Zoning Officer indicates that there was a recent sign violation associated with this property and there may also be an issue related to the underground storage tanks on the property that requires further clarification. Furthermore, it is possible (not confirmed) that some of the parking spaces, associated with this commercial use, may actually be located within the right of way of Route 23. Any requirement to remove those spaces would obviously affect the viability of this site for many types of commercial uses.

In summary, this property meets at least criterion “d” because of the overcrowded conditions on the site, the deficient size of the site, the non conforming use and the fact that the commercial use of this property, in its current configuration, is not consistent with modern planning standards. The proximity of the site to a residential area also raises health and safety issues.

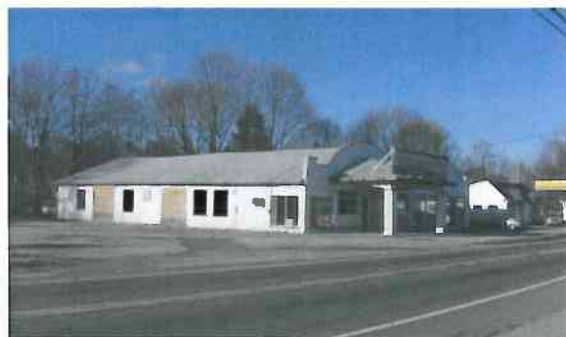
KULSAR’S GARAGE

The existing building is oriented toward the north side of the property and there is a large open, mostly unpaved area to the south of the building. From what is known about the former use of the building, as one of the first car dealerships in Sussex County and from a visual inspection of the structure, it is clear that this building was constructed prior to zoning. In addition, the building has been allowed to deteriorate in recent years as evidenced by the condition of the exterior walls and roof. However, the building has not necessarily reached the end of its useful life, although that conclusion will require further investigation as to its structural stability. In fact, if the building is salvageable, given its historic character, any redevelopment plan for this area may want to consider retaining and rehabilitating it and making it a focal point of any redevelopment project. However, given the existing site and building conditions and the placement of the building on the property, it may be more realistic to demolish the building, as part of any redevelopment plan.

In summary, this property meets at least criterion “d” because the current site design, including the placement of the building on the property, makes any adaptive re-use of the site or building, which would be in accordance with modern planning standards, difficult at best. Finally, please note that although this site is larger than the others in the study area, it is still substantially deficient in size, based on the requirements of the HC Zone.

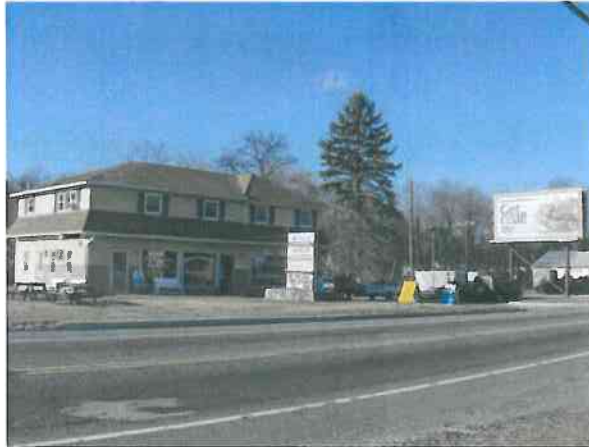
COMMERCIAL STRUCTURE – 407/409 ROUTE 23 - PARCEL D

The Tax Assessor’s records indicate that the structure was built in 1965. The building is of a typical non descript appearance common to that era and it is kept in reasonably good condition. However, given the age and design of the building it may be bordering on obsolescence, which may result in it becoming more difficult to keep the commercial space fully rented.

This property does not qualify on its own, although it comes very close to meeting the requirements of criterion d. However, it can be included in the redevelopment area, based on its importance to the preparation of a comprehensive redevelopment plan for this area, as authorized by the provisions of NJSA: 40A: 12-3.

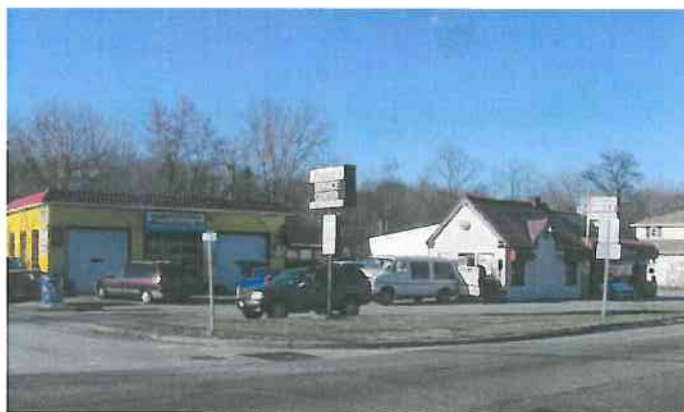
AUTO REPAIR FACILITY ON LEFT / DELI ON RIGHT

As already noted, there are two buildings on this relatively small site, which accommodate businesses that are not related to one another. Both buildings are very close to the road and the parking arrangement is substandard. It also needs to be noted that the visual and environmental impacts associated with the auto repair facility do not help foster a positive image of this part of Franklin, when one considers the very visible location of this facility at the intersection of Route 23 and High St.

In summary, this property meets at least criterion “d” because of the overcrowded conditions on the site, the deficient size of the site, the non conforming use and the fact that the commercial use of this property, in its current configuration, is not consistent with modern planning standards. There also may be health and safety issues relative to the proximity of the auto repair facility to a residential area
