**A RECOMMENDATION  
REGARDING  
THE DESIGNATION  
OF  
A PROPOSED AREA IN NEED OF  
REHABILITATION**

**AREA B**

**(MAIN STREET – FROM THE BOROUGH HALL TO HUDSON STREET )**

**JANUARY 9, 2012**

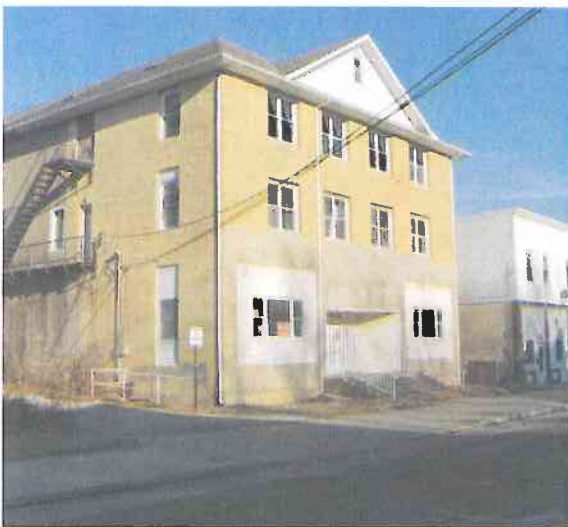
**55 MAIN STREET**

Specifically, with respect to the properties depicted in the photos, **55 Main St** was at one time the local movie theatre but it has been completely vacant for many years and there haven't been any recent proposals to make it a functioning part of Main St again. **80-82 Main St** is an example of a previous series of storefronts having been converted to residential units in an inappropriately aesthetic way, since the new ground level façade does not match the rest of the building. **91 Main St** accommodates one of the few businesses left on Main St but the bulk of the ground floor space is vacant and has been for several years. **143 Main St** is another vacant storefront and **127 Main St** is another example of a ground floor conversion from business to residential. Finally, **109 Main St** still accommodates a business, although it is a somewhat marginal, niche type business, that probably has a loyal but small following and which seems to have a limited schedule of store hours. The building owner, however, has maintained the architectural integrity of the structure and has set a good example for the rest of Main St

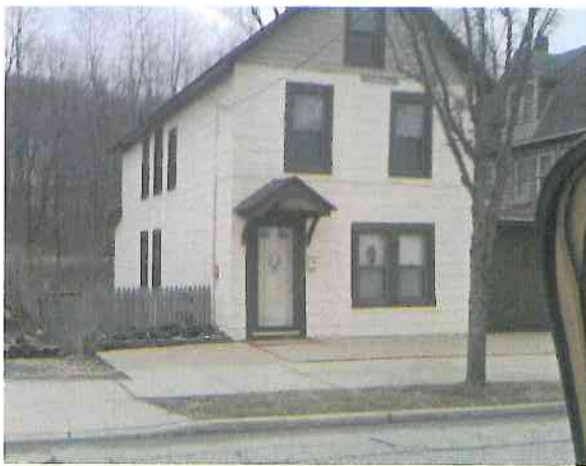
**106 MAIN STREET**

The two photos below provide examples of the types of residential structures found along Main St. **106 Main St** is a small “worker” type structure that probably dates back to the early days of the mining operation in the Borough. In contrast, **144 – 146 Main St** is a larger, multi family structure built for that purpose originally, with a large front porch and other features common to structures built in the beginning of the 20<sup>th</sup> century or earlier.

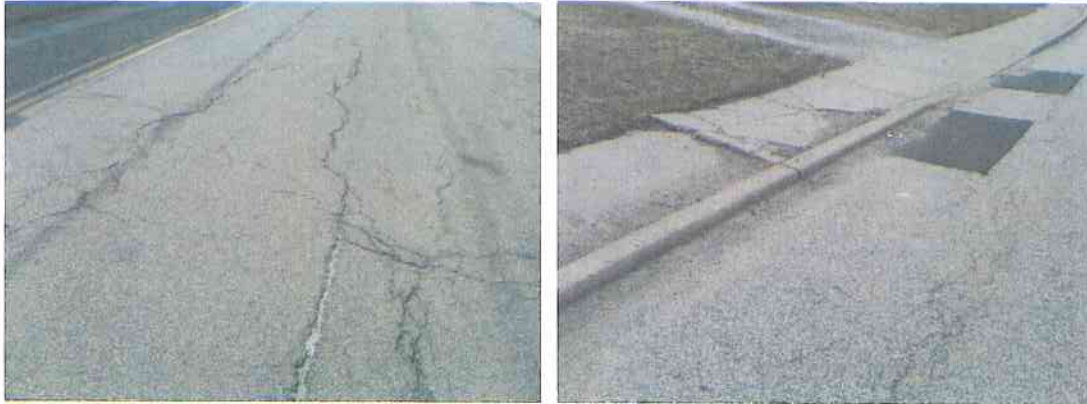
- In addition to the actual storm sewer pipes, certain above ground components, such as curbing, play a role in directing storm water. As can be seen from the following photos, taken in the vicinity 152 Main St., the curb face along many sections of Main St is now considerably less than the standard 6”. As a result, at times, surface runoff can easily leave the confines of the street and be directed onto adjoining properties.

- In addition to the storm sewer system itself, the condition of the Main St and portions of the sidewalk network are in need of repair and / or replacement, as can be seen by the following photos. Although the condition of these infrastructure

components does not yet threaten the health and safety of the community, they will be requiring attention in the not too distant future. As an example, it was just noted that some of the curb faces are less than the desired 6" height. This can only be partially corrected by milling the existing pavement and resurfacing the street. In some cases the existing curbs can remain but in others, new curbs will also have to be installed. The same is true of portions of the sidewalk network, which will need to be replaced in order to ensure that the drainage network can function as intended.

#### **EVIDENCE OF MAIN STREET PAVEMENT PROBLEMS AND DEFICIENT CURBS AND SIDEWALKS**

In summary, the Main St. infrastructure requires a substantial amount of work in order to correct existing problems and in order to help facilitate the revitalization of the Main St. area. Although some of the infrastructure components are less than 50 years old, particularly the sanitary sewer system, this does not negate the fact that much of the remaining infrastructure is over 50 years old and is in need of repair, replacement or substantial maintenance and, therefore, meets the statutory criteria required in connection with the designation of Main St as an **Area In Need of Rehabilitation**
